Lessons Learned From the Construction of Upgrades to the NASA Glenn Icing Research Tunnel and Re-Activation Testing

David W. Sheldon, Charles R. Andracchio, and Thomas M. Krivanek Glenn Research Center, Cleveland, Ohio

National Aeronautics and Space Administration

Glenn Research Center

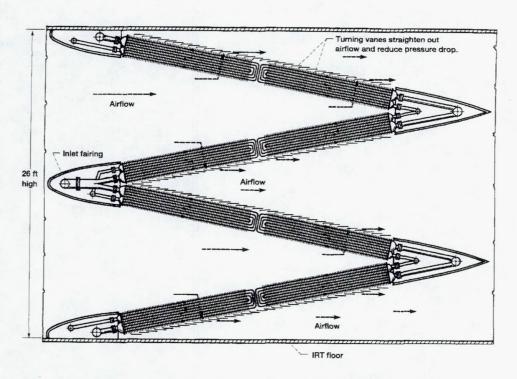
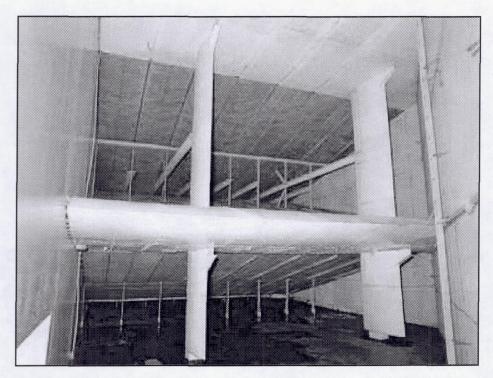
The Carrier Corporation installed the large copper tube-copper fin heat exchanger, with a nominal refrigeration capability of 2100 tons, in the IRT in 1943. After more than 50 years of service, the network of copper tubes was deteriorating to the point where the repair or closing-off of leaking tubes was responsible for about 100 hours of tunnel downtime each year. Leaks were occurring at silver-soldered joints at the end turns of the tubes, which were caused by the incompatibility of the R-134a coolant and silver solder.

Figure 2.—(Concluded) Original W-shaped heat exchanger in the IRT.

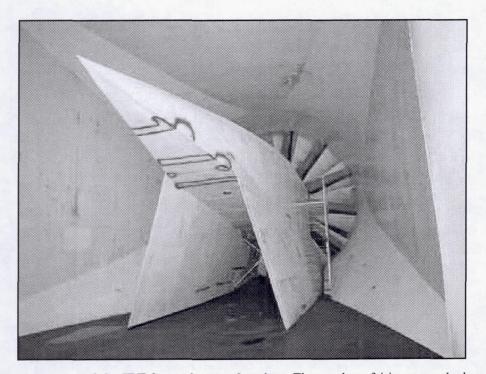
Figure 3.—View upstream of the IRT fan and motor housing. The two long fairings over the legs of the motor support platform are theorized to cause large variations in downstream air velocities.

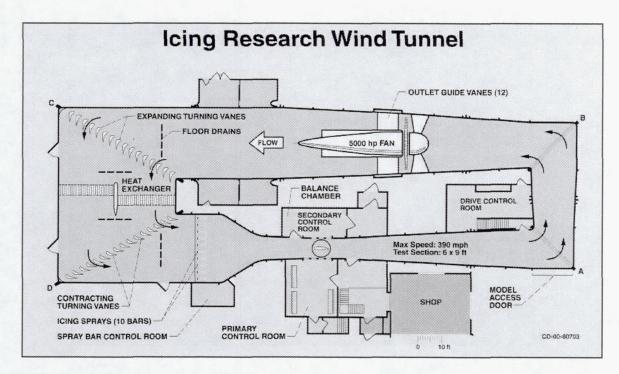
Figure 4.—Loop configuration of the IRT after the 1999 modifications. The width of the new C-D leg has been increased 69 percent to accommodate a flat heat exchanger, new turning vanes have been installed in Corners C and D, and new outlet guide vanes have been installed around the fan motor housing. The electronic controls in the drive control room have also been replaced.

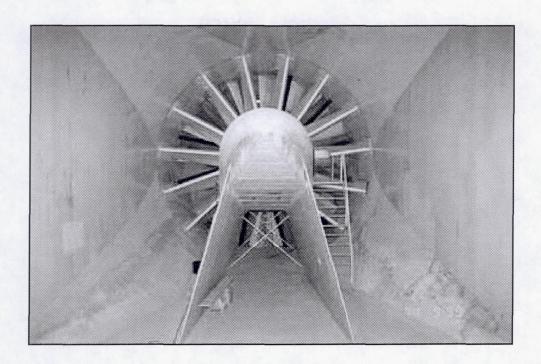
Figure 6.—Installation of the 12 fan OGV's around the motor housing. Views is upstream. Fan blades can be seen in the background. The leg fairings take the place of two additional OGV's. The OGV at the six o'clock position has been eliminated because it would block the primary access path to the fan blades. (C-99-2410)

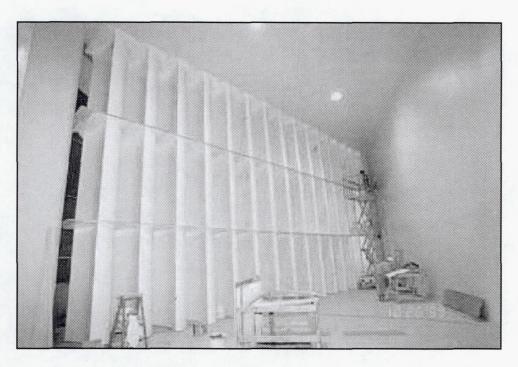
New cascades of turning vanes were installed in Corners C and D, each consisting of 16 hollow fiberglass airfoils 26.2 feet (7.98 m) in span and oriented vertically. As shown in **Figures 9, 10,** and **11,** these vanes were fabricated in three sections and tied together by horizontal fiberglass plates. The tie plates were anchored to the tunnel's inner wall to help carry the lateral airloads on the turning vanes. These custom-designed turning vanes expand the flow in Corner C and contract the flow in Corner D, and their unique aerodynamic shapes make them relatively insensitive to incoming flow angles. The large size of the flow paths between vanes permits personnel access to either face of the HX, for inspection and repair work.

Figure 9.—Installation of the new fiberglass-composite turning vanes in Corner C. The horizontal tie plates between the vane segments help carry airloads directed outward along the corner diagonal. Socket connections at the ceiling provide for differential thermal expansion and contraction. (C-99-2287)

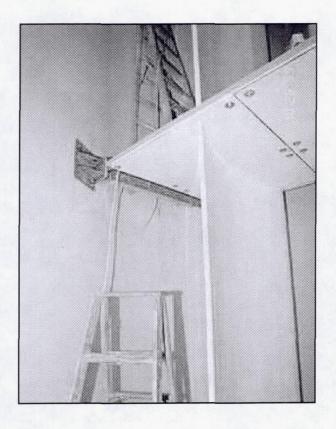
During flow quality testing in the stilling chamber downstream of the Corner D turning vanes, it was determined that the flow distortions of the bolted flanges and the tie plates had been underestimated. The wakes of these extraneous structures cause small local decreases in the downstream flow, and the extra pressure drops cause a small decrease in the maximum test airspeed in the tunnel. Leading-and trailing-edge fairings have now been added to the tie plates in Corner D. Improvements in flow quality are expected, but these have not yet been verified by test.

Figure 11.—View in Corner C of the trailing edge of vane C-1, showing the outer end of a tie plate sandwiched between bolted flanges. The reinforced end of the tie plate bears against brackets on the outer wall of the tunnel. (C-99-2432)

Recommendation: During the design phase, exercise more care in predicting the aerodynamic effects of alterations to an airfoil design, even when the alterations appear to be minor. Do not permit deviations from a clean aerodynamic profile unless absolutely necessary. For example, a smooth socket joint between segments of the turning vanes should have been considered before a flanged and bolted joint.

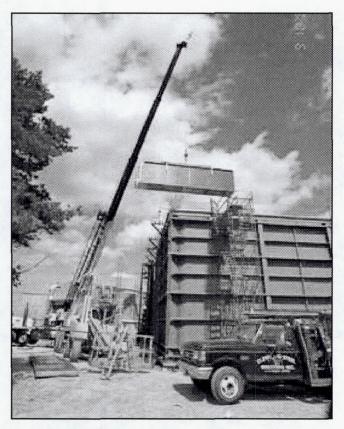
Figure 12.—Construction of the new Corner D and placing of one of the eight heat exchanger modules. (C-99-1997)

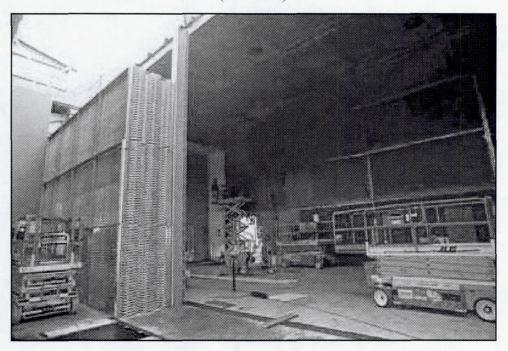
The replacement heat exchanger, located in the new C-D leg, presents a flat surface to the airflow, in order to eliminate the flow distortions caused by the "W" shape of the original HX. The new HX consists of eight identical modules stacked in two sets of four, to form two separate units. Figures 12 to 15 show the installation of the new HX modules. Each module is divided into three zones in the flow direction, and each zone has its own supply and return headers for the coolant, R-134a. Coolant tubes run horizontally from a secondary supply header at the tunnel wall to midtunnel and then turn 180 degrees and back to a secondary return header. The units are offset from one another as shown in Figures 5 and 14, to permit inspection and maintenance of the U-fittings welded onto the ends of the coolant tubes at mid-tunnel.

Figure 13.—Interior view of the new Corner C during construction, with three heat exchanger modules in place. The end turns in the aluminum coolant tubes indicate the locations of the three streamwise zones in each module. The coolant flow in each zone can be controlled independently, to minimize temperature variations in the outflow. (C-99-2005)

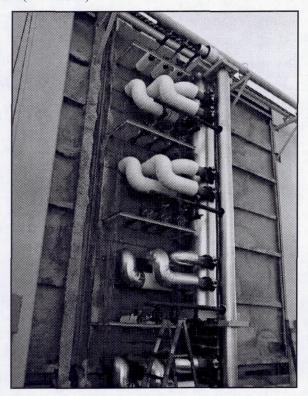
7. The design of the coolant supply pipes called for only a single pressure gage at the top of each of the two main supply headers from which the two units of the HX received coolant. As a result, pressures throughout the system of headers and secondary headers were unknown during the checkout and balancing of the HX modules. Additional gages were required that had to be installed during the reactivation test phase, which caused project delays.

Figure 15.—View of the HX coolant supply (smaller diameter) and return (larger diameter) pipes on the West wall of the new C-D leg. Separate pairs of pipes are connected to each of the three streamwise zones in each of the four HX modules that are stacked vertically to form the West HX unit. (C-99-2655)

Recommendation: For a complex multi-path flow system, like the coolant supply piping to the HX modules, locate sufficient pressure gages for checkout and balancing, and not just the few needed for routine operation.

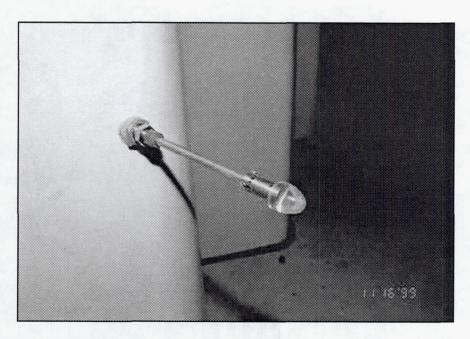
Larger numbers of thermocouple probes were installed in Corners C and D, in order to measure the distribution of air temperature across the flows entering and leaving the HX and monitor the thermal performance of each of the eight HX modules. These probes are mounted on the leading edges of the fiberglass turning vanes, as shown in **Figure 16**. Sixteen probes were installed on the Corner C turning vanes, with two probes at the midelevation of each HX module. Twenty-four thermocouple probes were installed on the Corner D turning vanes, with three at the midelevation of each HX module. Each probe contains two Type T thermocouples for redundancy. One signal goes to the WDPF tunnel control system computer and the other goes to the Glenn ESCORT data acquisition system.

Figure 16.—Typical thermocouple probe mounted on the turning vanes in Corners C and D. Probes point directly upwind and contain two Type T thermocouples. The nosepiece protects the thermocouple from ice and water, and the tubular sheath has holes that admit air at near-zero speed for accurate measurement of total temperature. (C-99-2438)

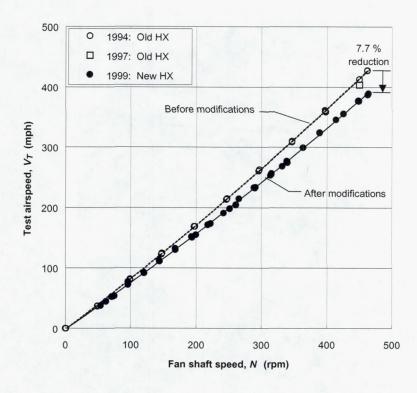
conditions. It can be seen from this chart that the maximum airspeed attainable in the IRT has decreased from its historic high of 420 mph (188 meter/s) measured during the 1994 qualification of new fan blades to approximately 390 mph (174 meter/s) today. This decrease is attributed to an approximately 50 percent increase in the drag losses across the flat HX compared with the original W-shaped HX, and to more drag loss than expected at the OGV's.

Figure 17.—Comparison of test airspeeds achievable in the IRT before and after tunnel modifications. Maximum airspeed was reduced approximately 8 percent.

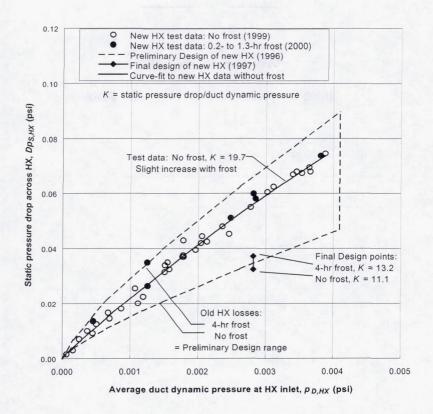
In Figure 18, pressure drops measured across the new HX are compared with design pressure drops. The range labeled "preliminary design" is a direct application of pressure drops measured across the original W-shaped heat exchanger, where heavy frost doubled the pressure drop. 16 In the final design of the replacement HX, however, frost was expected to cause only a small increase in the pressure drop. The two final design points at the bottom of the range show this, which represent operation at a test airspeed of 300 mph (134 meter/s). Pressure losses across the new HX with or without frost were expected to be about the same as those with the original HX in a dry condition. Examination of the actual pressure drops measured across the new HX with and without frost shows that the minor effect of frost was correctly predicted. While the pressure losses without frost at the design point are about 70 percent higher than predicted, losses for the frosted condition are still lower than those for the original HX. Therefore, these additional drag losses at the HX are not expected to significantly affect tunnel operations during icing tests at moderate airspeeds and with test section blockage.

10. When static pressures were measured upstream and downstream of the new HX, it was determined that the pressure drop had been underestimated by about 70 percent during the final design phase. It is clear from this large error in predicting pressure losses that the procedures used for calculating the aerodynamic drag of this type of HX are not acceptable. However, the minor effect of frost on pressure loss was predicted correctly.

Figure 18.—Comparison of measured and design pressure drops across the replacement heat exchanger. Measured pressure drop is approximately 70 percent higher than the final design.

Recommendation: Use the measured loss coefficients from these IRT tests to calibrate improved methods for predicting the aerodynamic drag losses in HXs of this general configuration.

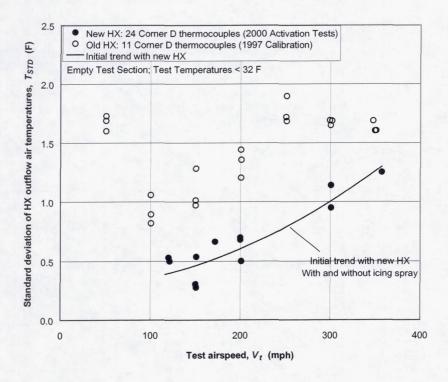
Figure 19 illustrates the improvements obtained in air temperature uniformity with the replacement HX. In this chart, the standard deviation of air temperature measured downstream of the HX, at the entrance to Corner D, is plotted versus the test airspeed. Deviations are approximately 0.6 F (0.3 C) less with the new HX than with the old, which is a reduction of approximately 50 percent at a test airspeed of 200 mph (89 m/s). Therefore, all PRVs were placed in a full-open condition pending their removal during a future

Figure 19.—Improvement in the uniformity of temperature in the outflow of the replacement heat exchanger, compared with the original heat exchanger. The standard deviation of the temperatures measured with the array of thermocouples in Corner D is used as the measure of uniformity.

- 4. Remote control of individual cooling zones in the replacement heat exchanger is not required for temperature uniformity downstream. Remote control pressure regulating valves can be removed from the system, reducing the coolant pressure drop through the heat exchanger and increasing maximum coolant flow rates.

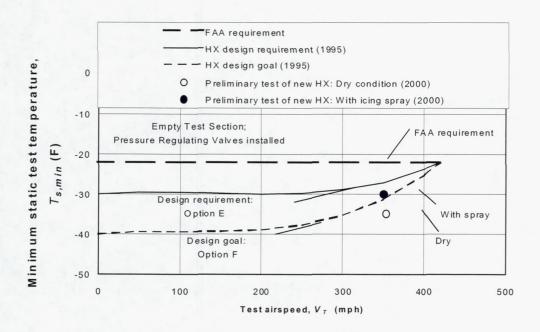
Testing of the current low-temperature capability of the IRT was begun, but has now been postponed until the remotely controlled coolant valves have been removed, because this should improve the results of the tests. Figure 20 shows the preliminary low-temperature data obtained with the PRVs in place and fully open. In this chart the minimum static temperature attainable is plotted versus the test airspeed. The FAA requirement of -22 F (- 30 C) is shown, together with the design requirement for the new HX (Option E) and a more ambitious design goal (Option F). These options represent upper and lower bounds on low-temperature test data measured in 1995 with the original W-shaped HX in operation. The test data shown in the figure are at an airspeed of 350 mph (156 meter/s) with all pressure regulating valves in place, with and without an icing spray.

Figure 20.—Preliminary lowest-temperature data obtained with the pressure regulating valves in place and fully open.

- 5. Preliminary test data indicate that the low-temperature performance limit of the upgraded IRT will meet the design goal under dry conditions and the design requirement under icing conditions, exceeding FAA requirements. The complete range of low-temperature limits is not yet defined as a function of airspeed, blockage, and spray conditions. The planned facility performance test has been postponed until the remotely controlled valves in the heat exchanger are removed (see Conclusion 3).

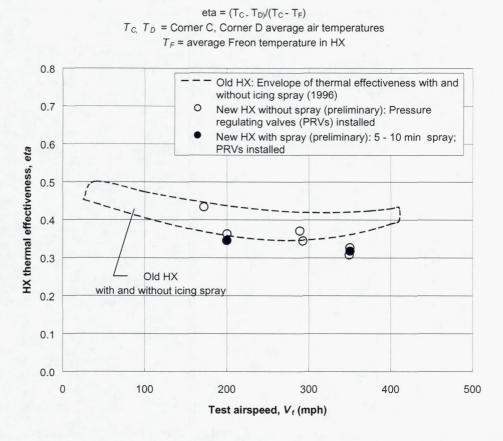
A quantitative measure of the cooling performance of a heat exchanger is its thermal effectiveness, defined as the ratio of the drop in air temperature across the HX to the difference between the inlet air temperature and the internal coolant temperature. In Figure 21 some preliminary data on the thermal effectiveness of the new HX are compared with performance data for the original HX. As expected, the higher face (inlet) airspeeds into the new HX reduce its thermal effectiveness somewhat, compared to the W-shaped HX with its much lower face speeds for the same test airspeed. However, these preliminary data still indicate that the performance of the new HX under icing test conditions will meet design requirements and may be close to the design goal shown in Figure 20 after the 24 PRVs are removed.

Figure 21.—Preliminary comparison of the measured thermal effectiveness of the new HX with that of the original HX.

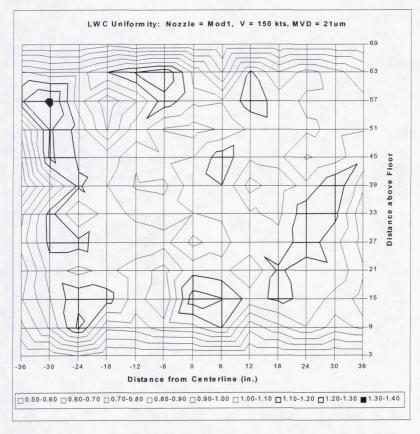
used to record ice thickness data. **Figure 23** is a typical contour plot of the variability of ice accretion across the Test Section, expressed as deviations of local thickness from the average thickness.

Figure 23.—Typical contour plot of the variability of ice accretion across a 6-ft by 6-ft (1.8-m by 1.8-m) zone in the middle of the Test Section.
